CASE STUDY 01

CASE STUDY 02

CASE STUDY 03

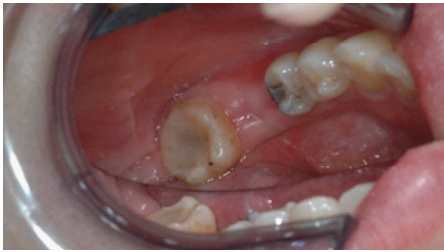
Fig. 01 Good soft tissue healing.

Two months and three months follow up showed normal tissue contour at the extracted site with no scarring effect or tissue defect (Fig. 01).

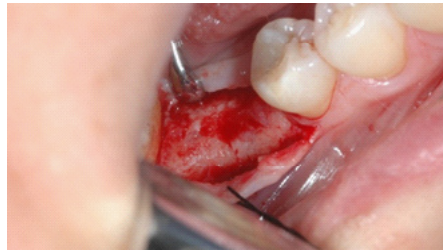
Fig. 02 Good bony socket width after 5 months.

Patient came back after five months for implant placement at the healed site. At five months, the same site showed good bony contour with well maintained height and width with no bony defects (Fig. 02 and Fig. 03).

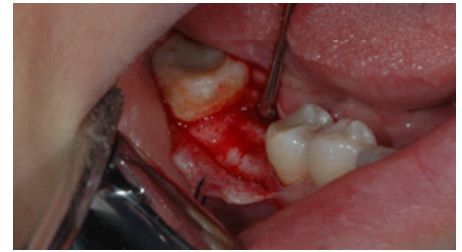
Fig. 03 Good alveolar height preservation.

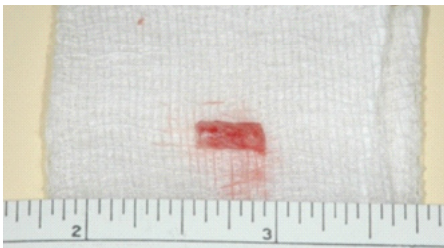
Fig. 04 Extracted bone piece (ruler in mm).

To assess the bone quality of the healed socket site, a sample of bone was trephine out from the healed socket area for histopathological examination and micro CT (Fig. 04).

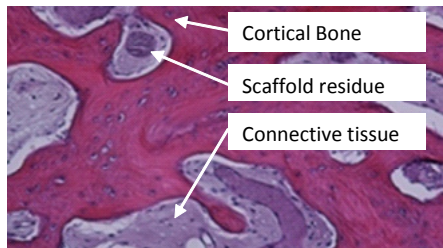
Fig. 05 Histopathological picture of the trephined bone.

The histopathological slides were made in the histopathology lab, faculty of Dentistry, NUH, Singapore and the report was given by A/P Yeo Jin Fei, Head of the OMS Department, NUH, Singapore (Fig. 05). The histopathological report shows cortico-cancellous bone with many interconnecting trabeculae of new bone formed in association with small fragments of PLGA scaffold materials while undergoing varying stages of degradation and being replaced by new bone associated with previous cancellous bone. Section shows almost no or few inflammatory cells within the marrow space.

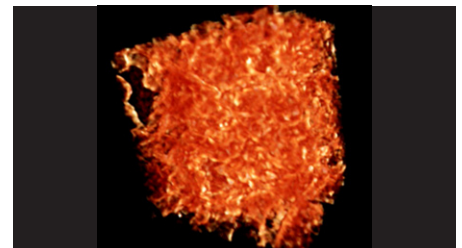
Fig. 06 Micro CT of trephine bone.

The micro CT of the trephine bone (Fig. 06) shows normal healthy bony structure similar to that of the normal bone (Fig. 07).

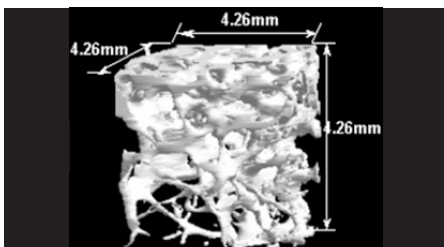
Fig. 07 Micro CT of normal bone.

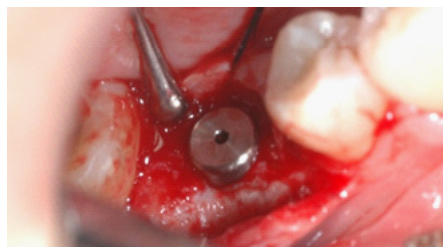
Fig. 08 Implant.

After trephine out of the bone piece, an implant (Fig. 08) was placed at the same prepared site with good initial stability.

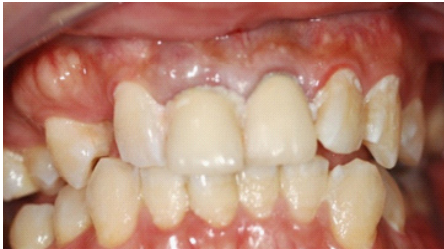
Fig. 01 Picture before extraction showing bad oral hygiene.

A male patient of age 38 had a fractured 11 which was root canal treated and restored with a post crown. The tooth is fractured transversely and subgingivally. Fractured post crown and remaining tooth was beyond salvage (Fig. 01). There is an existing apical lesion from the failed root canal treatment and can be seen in the OPG. Patient oral hygiene was bad with lots of plaques and calculus.

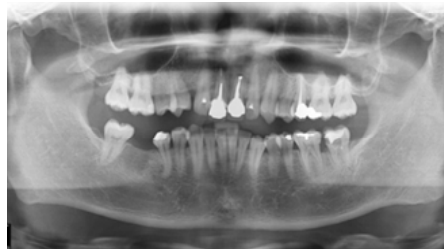
Fig. 02 OPG showing root canal treated 11 with apical lesion.

An OPG was taken before extraction clearly showing the apical lesion (Fig. 02).

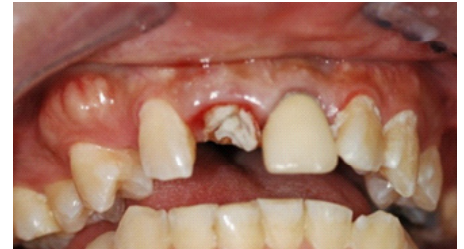
Fig. 03 Dislodged crown was taken out first.

Extraction was done and the coronal portion was removed first. The root was extracted atraumatically with periostomes (Fig. 03).

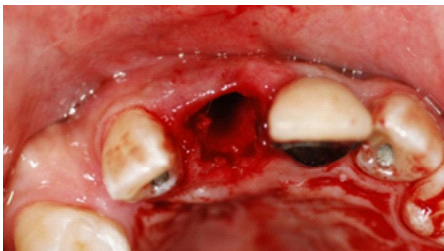
Fig. 04 Socket cleaned of all infected debris.

Socket was cleaned of all infected debris (Fig. 04) and scaffold was placed horizontally at the crestal level (Fig. 05). Healing was good after a week and suture was removed. There was no complain or complicity from the patient.

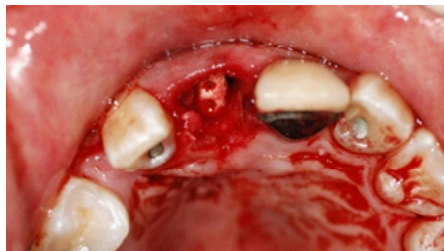
Fig. 05 Scaffold placed horizontally at crest level.

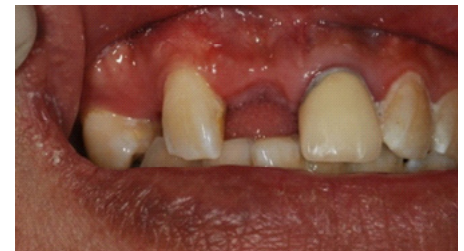
Fig. 06 10 month follow up shows well tissue contour. Socket height is preserved.

Patient came back again after 10 month for a follow up visit as he is planning to have implant for his missing 11. While the patient's oral hygiene continues to be bad, it was however clear that the extracted socket showed minimal height loss as seen in the picture (Fig. 06). Width loss was observed to be insignificant and is likely to be due to the patient's early apical infections and bad periodontal condition.

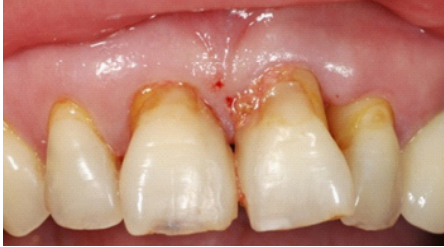
Fig. 01 Before extraction showing two upper central incisors.

A female patient of age 59yrs came to the clinic with periodontically involved two upper central incisor and the teeth were beyond salvation (Fig. 01). An OPG was taken before extraction clearly showing the condition of the teeth and surrounding bone which is already not so good (Fig. 02). The bone height is already far below the cervical margin and only half or so socket was remaining. So to preserve the remaining socket bone, socket preservation was done with Alvelac™. An atraumatic extraction was done with periostomes and 21 was removed first followed by 11 (Fig. 03 & Fig. 04).

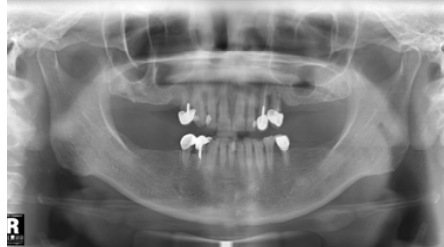
Fig. 02 OPG showing periodontically involved 11 and 21 with severe bone resorption.

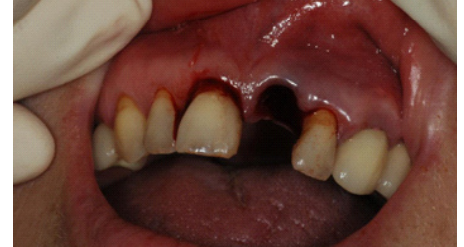
Fig. 03 Atraumatic extraction of 21 done.

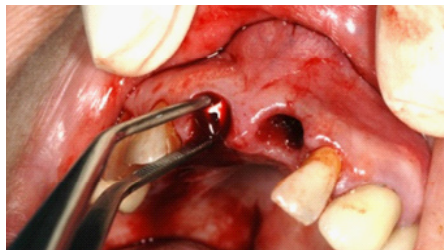
Fig. 05 Scaffold placed horizontally at crest level.

Socket was cleaned of all infected debris and scaffold was placed horizontally at the crestal level (Fig. 05). Two 3.5×4.0mm scaffold was used which resembles the width of the socket at crest level (Fig. 06).

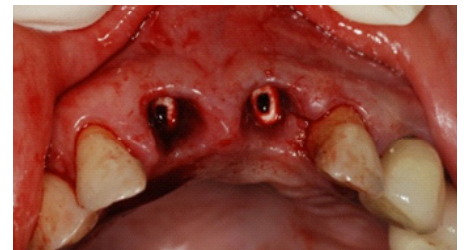
Fig. 06 Scaffold placed at crest level which is far below the cervical margin.

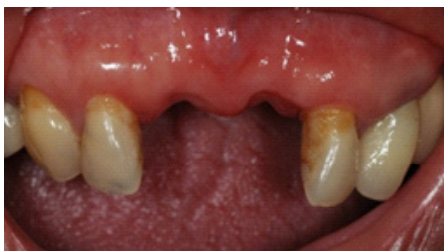
Fig. 07 Seven month follow up shows well tissue contour.

Healing was good after a week and suture was removed. There was no complain or complicity from the patient. Patient came back again after 7 month for a follow up visit (Fig. 07) as she is planning to have implant for her missing 11 and 21. At 7 month re-entry, the alveolar ridge height is almost at the same level as the time of extraction though there is a bit of height loss at the 21 site (Fig. 08). The thickness of the ridge was already compromised at the time of extraction and now it is just ok for a 4×11mm implant (Fig. 09).

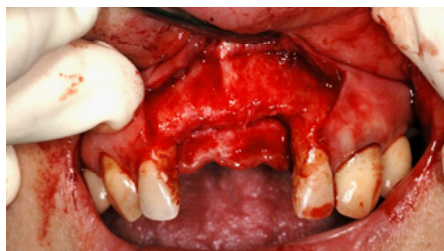
Fig. 08 Socket height is preserved at almost the same level as after extraction.

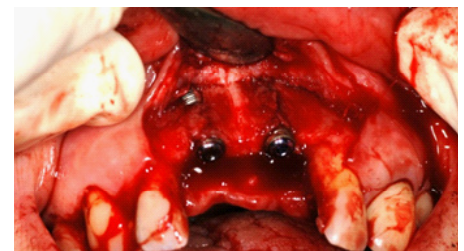
Fig. 09 Two 4×11mm Osstem implant is placed in site.

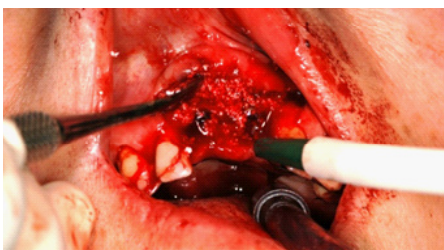
Fig. 10 Labial defect was grafted with xenograft.

As the thickness of the ridge was already compromised, there was labial exposure of implant threads and needed a bone grafting. Xenograft was used for grafting and was covered with a resorbable membrane (Fig. 10). Mucoperiosteal flap was replaced and sutured with 3.0 vicryl. An immediate denture was given to restore the aesthetic look of the patient (Fig. 11).

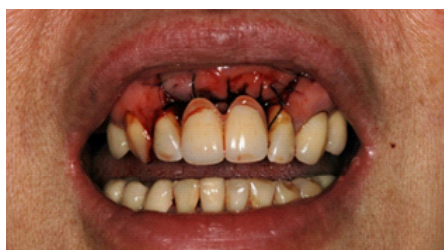
Fig. 11 An immediate denture is given to the patient for aesthetic purpose.
